Dynamics and conceptual model of the Rossena castle landslide (Northern Apennines, Italy)

Part of Special Issue “Documentation and monitoring of landslides and debris flows for mathematical modelling and design of mitigation measures”

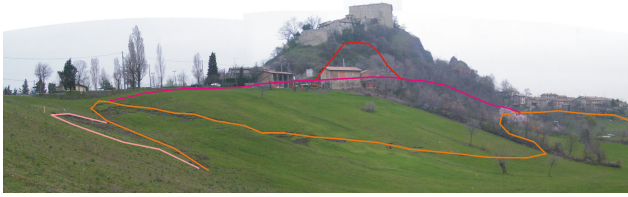
Fig. 1. Panoramic view of the higher part of the Rossena Landslide. Keys: orange line = main body (rotational), purple line = earth slide (translational), red line = rock slide, pink line = secondary landslide.

This paper describes an interesting landslide, failed during the night of 28 February 2004, that involved the village of Rossena: the failure damaged the village (Fig. 1), the road and the fields down to the stream but, fortunately, the castle just upslope the village was not involved at all.

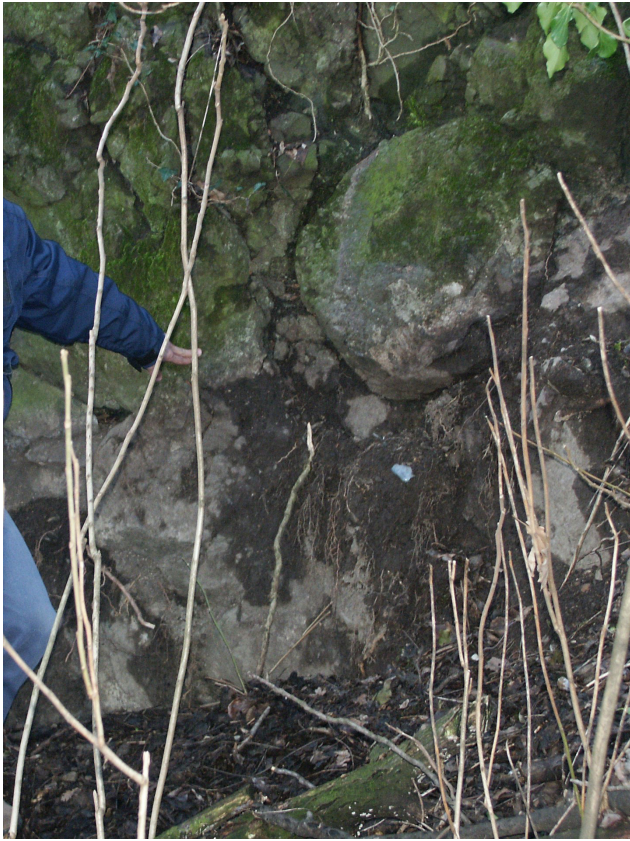
Fig. 5. Vertical offset between stable basaltic cliff and dismembered blocks.

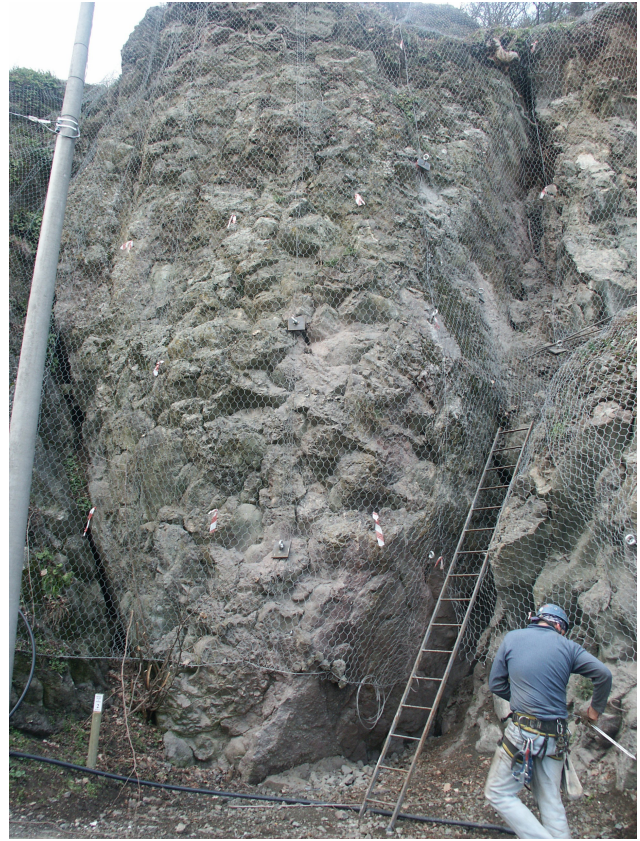
Fig. 6. Unstable basaltic block at the base of the cliff.
